**“Alternative 6”
 Planned By Fish First
 But Later Rejected
 By Agencies**

**Completed
 Lewis River Ridge
 Project: Oct. 2008**

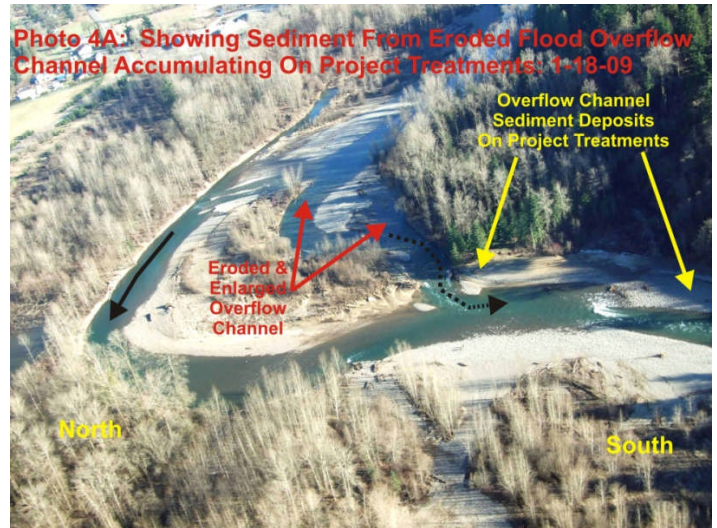
Photo 4A: Showing Sediment From Eroded Flood Overflow Channel Accumulating On Project Treatments: 1-18-09

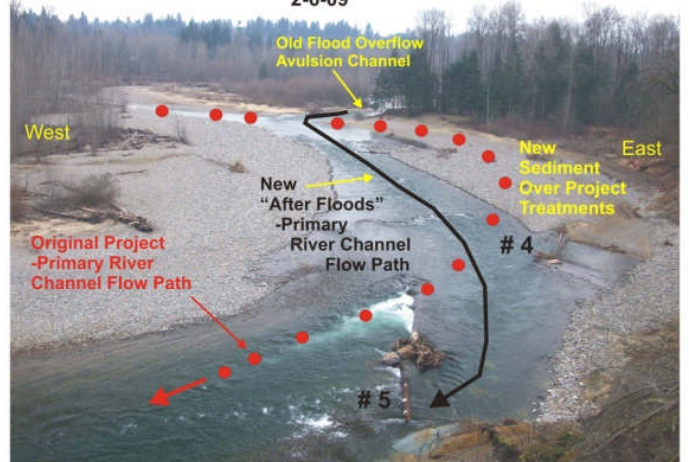
Photo-10B: New Primary Stream Flow Path About 29 Days After 3rd Flood, Showing Pre-Flood & Pre-Avulsion Project Design Channel In Red & New After Floods Primary Channel Location, Which Avulsion Sediment Created: 2-6-09
